SUPSI

Investigations on the Main Causes for Reduced Performances during the Early Stage of Life of Rooftop PV Systems

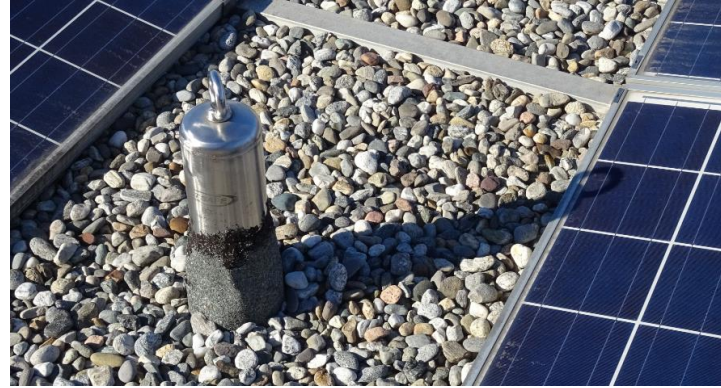
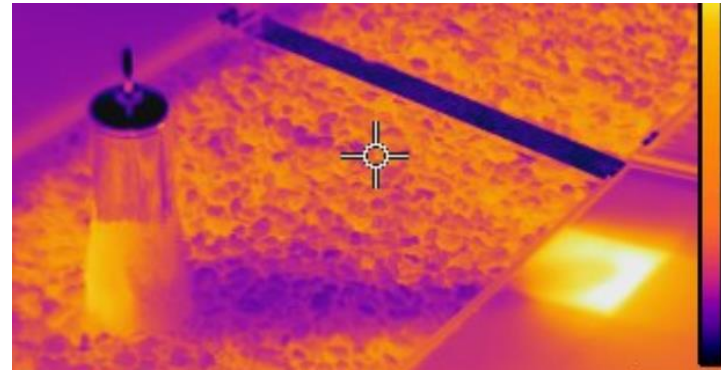
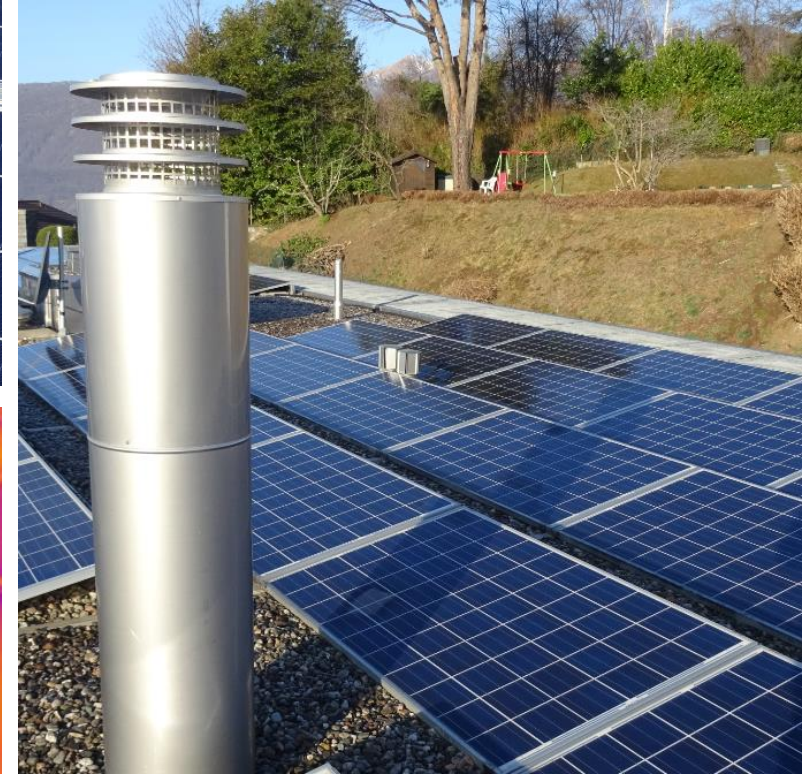
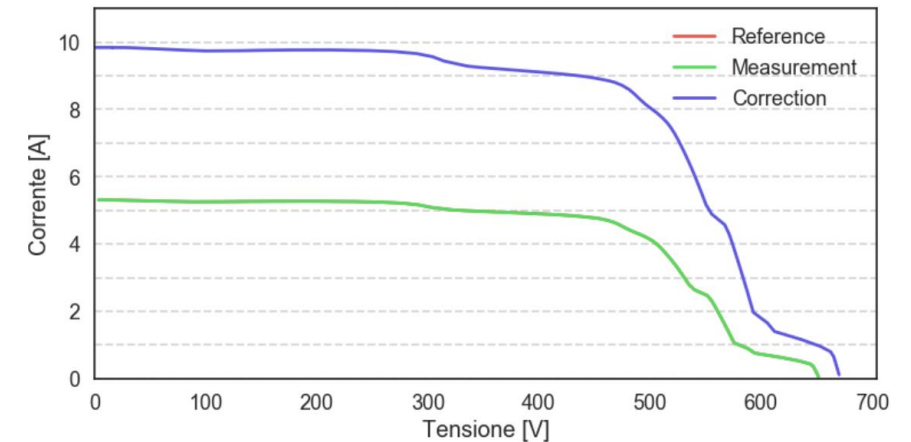
- **Permanent** partial shadows!
 - Mutual shadows
 - Chimneys
- **Temporary** partial shadows:
 - Chimneys
 - Trees
 - Poles
 - Antennas
- and corresponding **electrical wiring**

I-V curve with module permanently shaded (measure and STC)

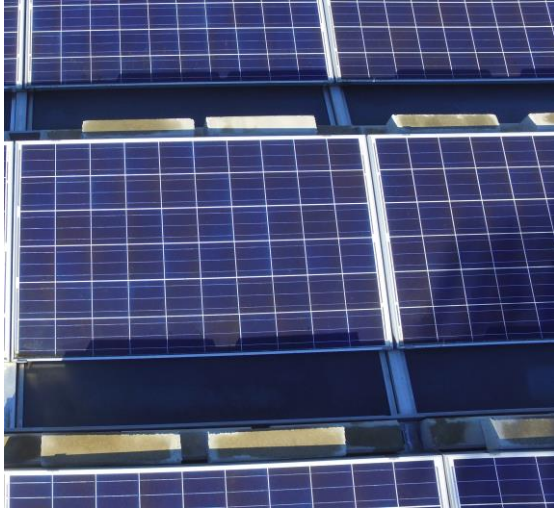
Mutual shadows

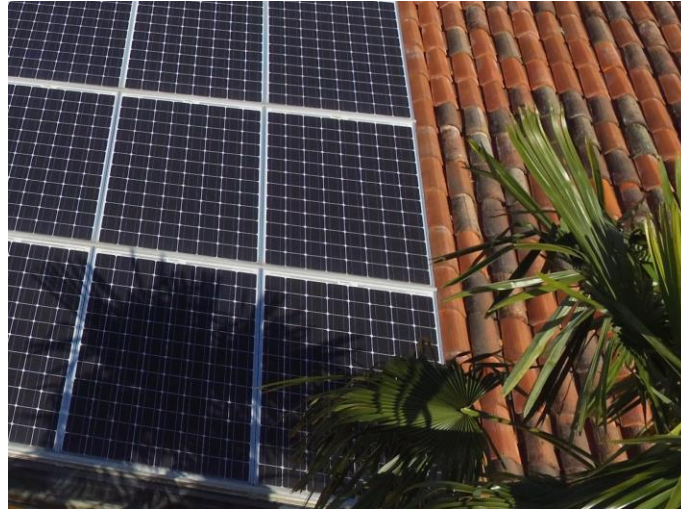
Tree shadows

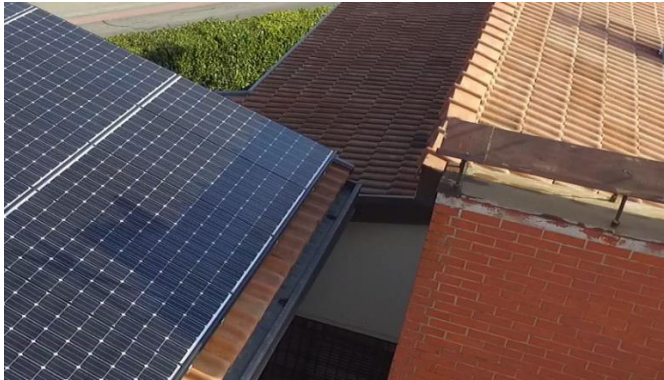
Near building shadows

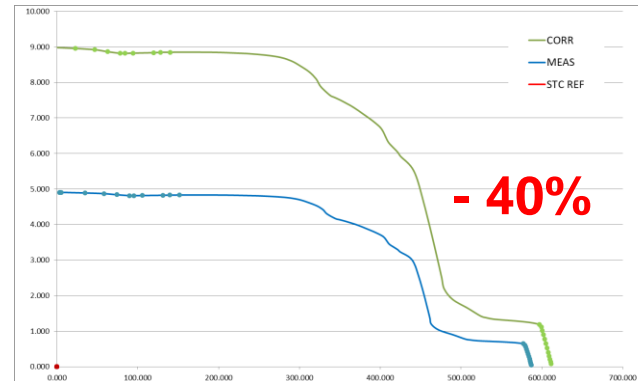
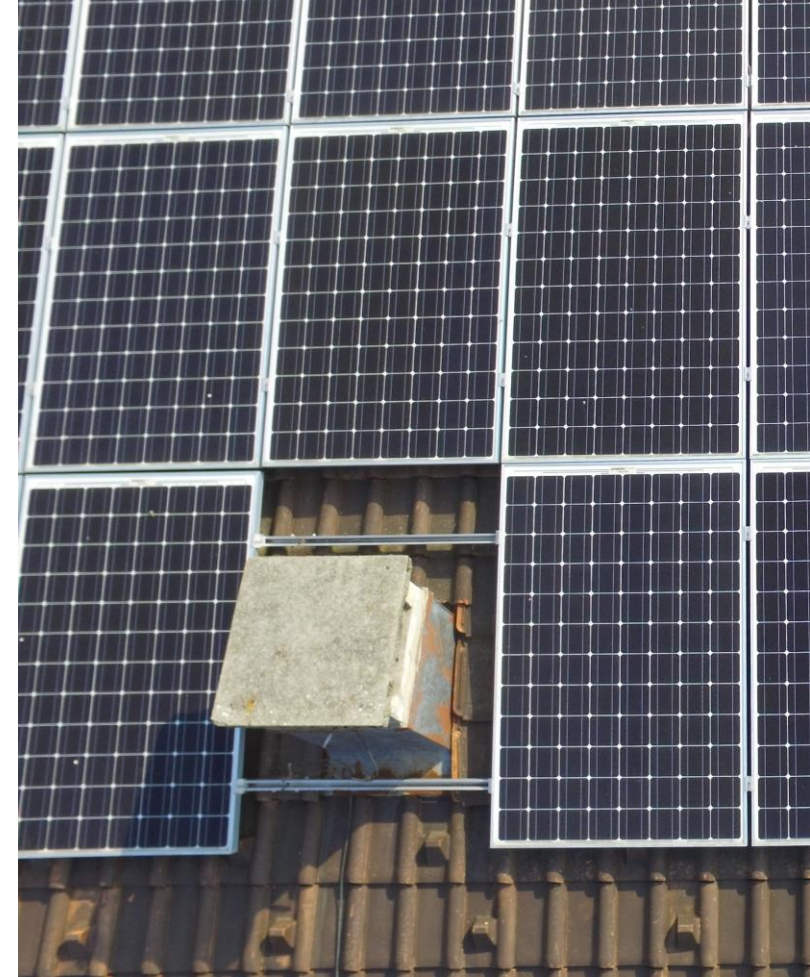
Chimney shadows

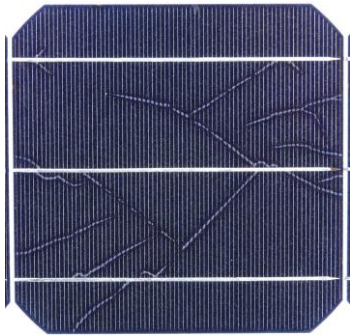
Cell defects

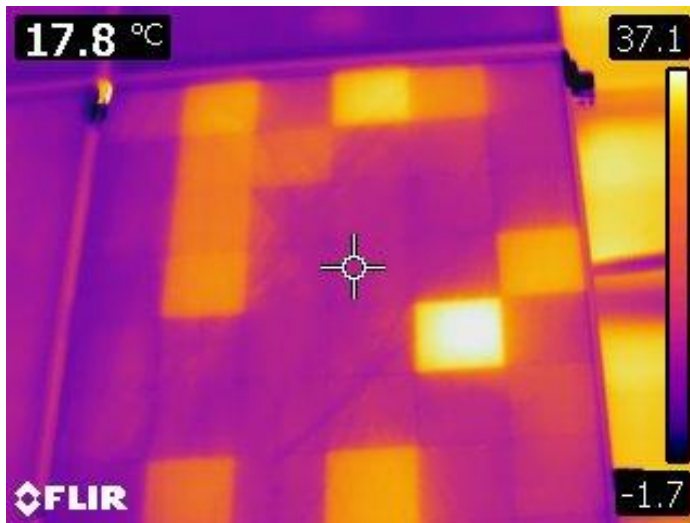
Dummy module in Isc instead Voc

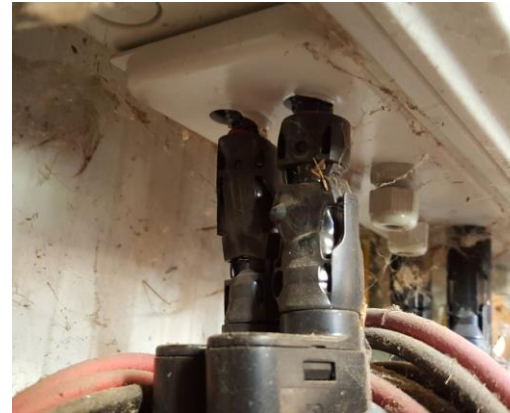
Layout and wiring error

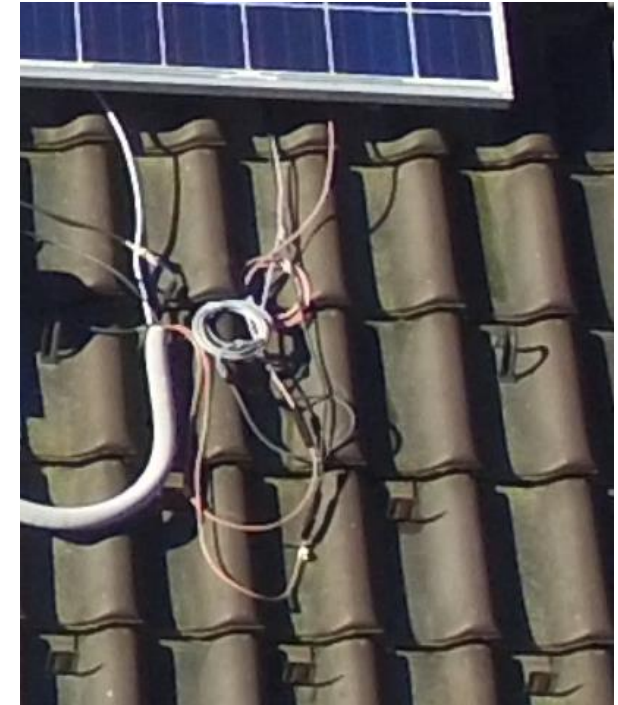
Poor wiring

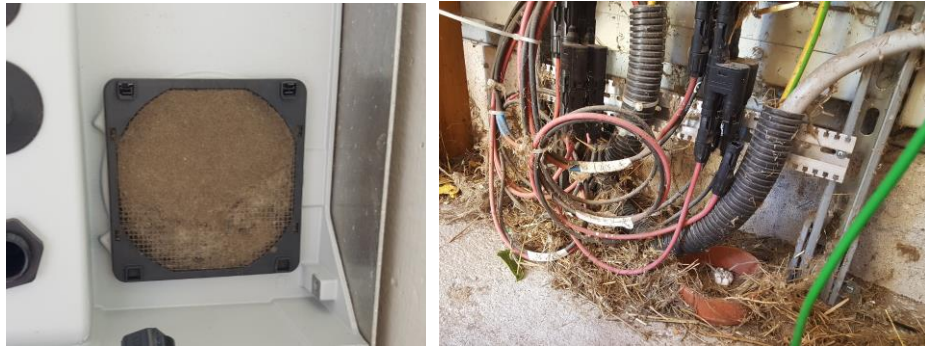
Dirty Inverter filter: derating in power

- Monitoring (monthly values but at least annual value)
- Comparing (with expected simulated performance)
- Annual maintenance (cleaning modules and inverter filters, cutting trees and hedges)

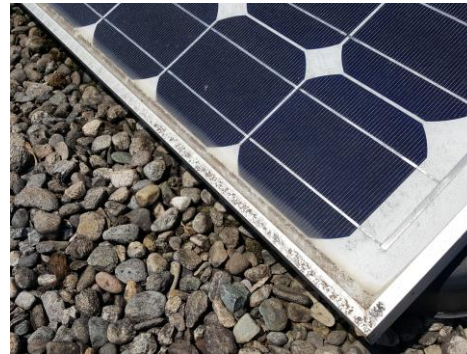
Soiling on bottom edge in proximity to the ground:

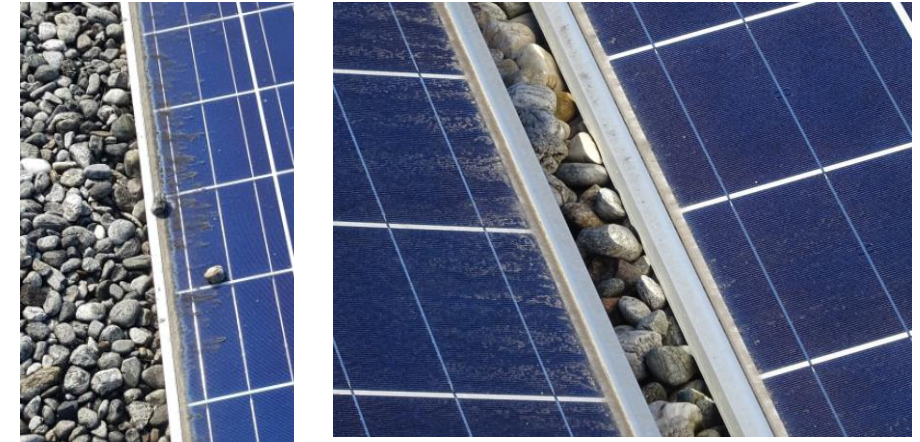
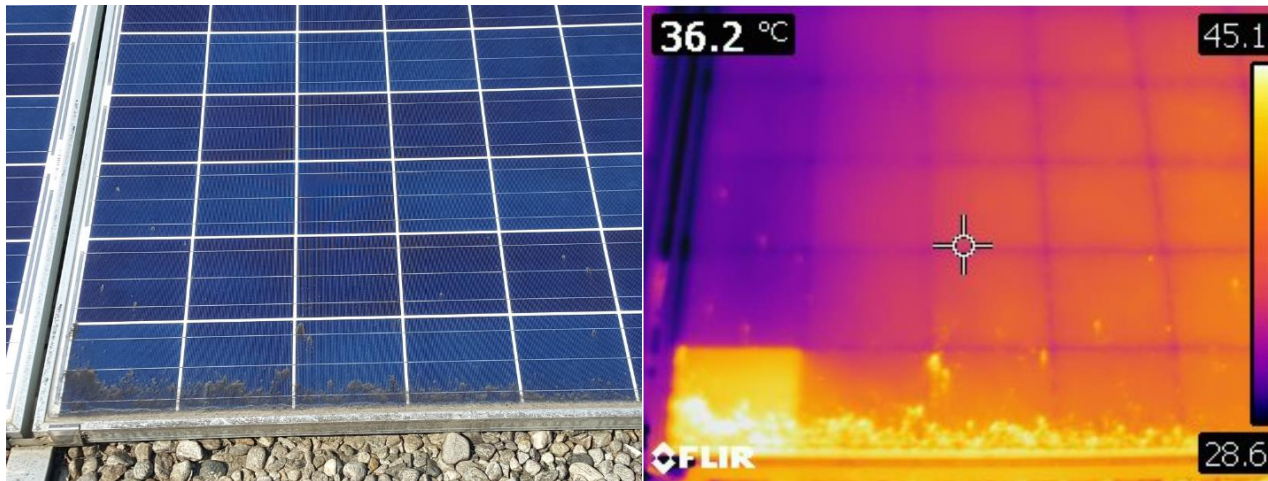
Soiling on the bottom edge of the modules can cause hot spots

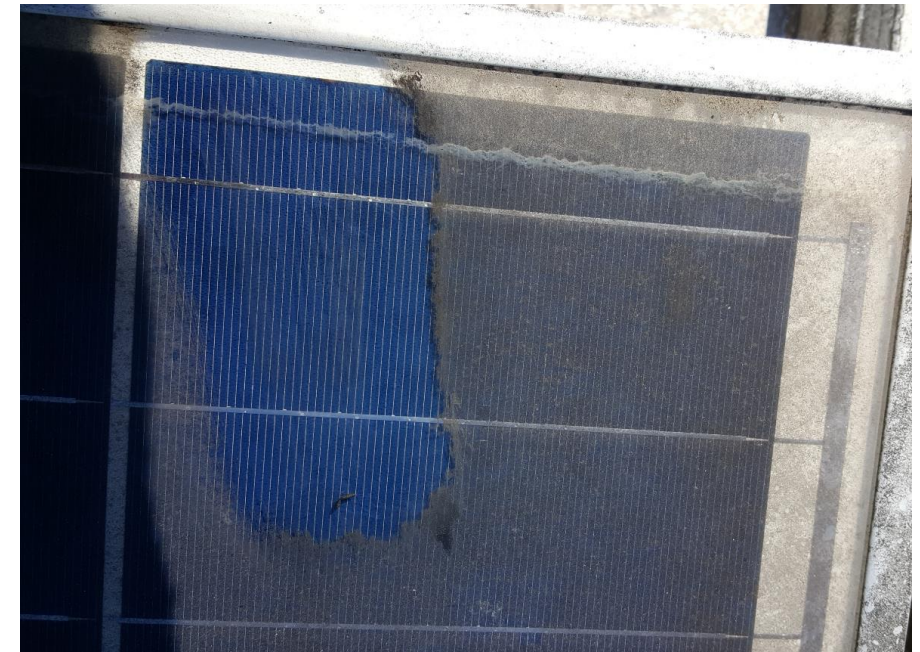
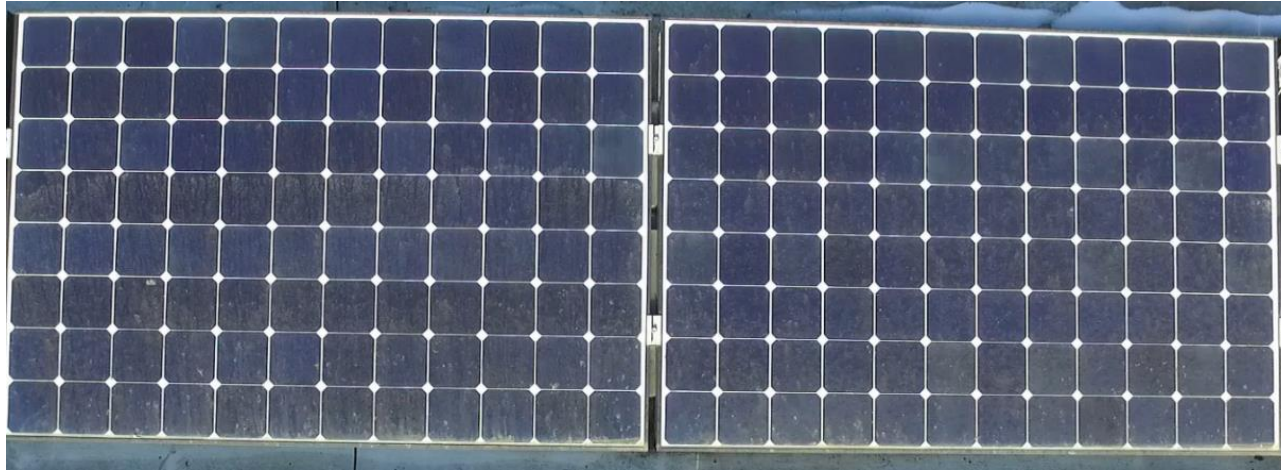
- No hot-spot but lower performance (e.g. -30%)
- Soiling is not always uniform but heterogeneous: it can accumulate in some parts of the modules or of the strings
- Farms and agriculture are more sensitive

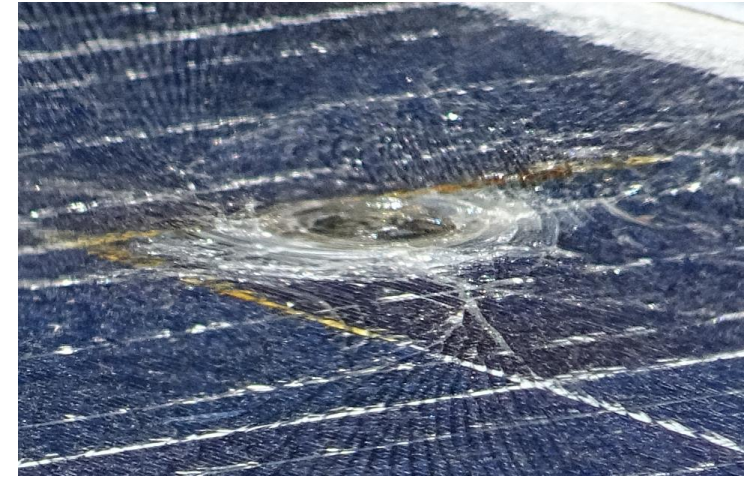
Short circuit / lightning or hot spot ?

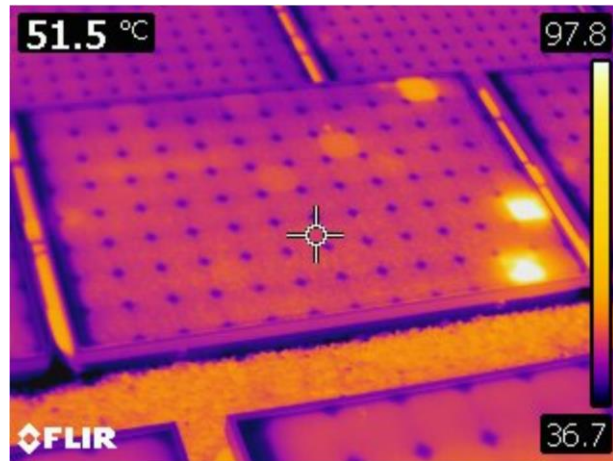
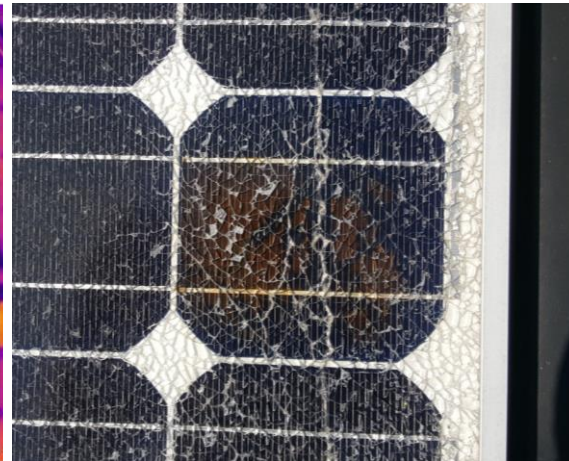
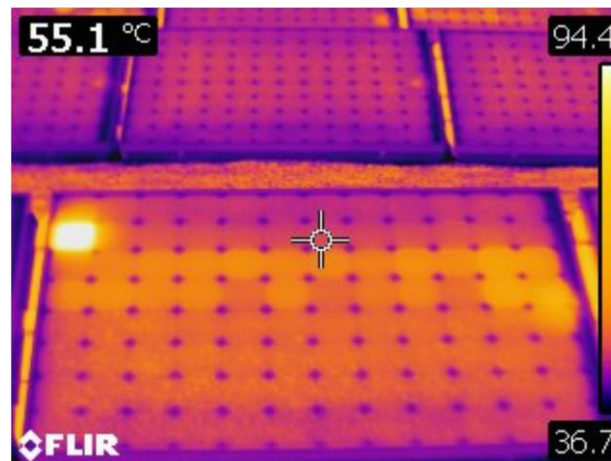
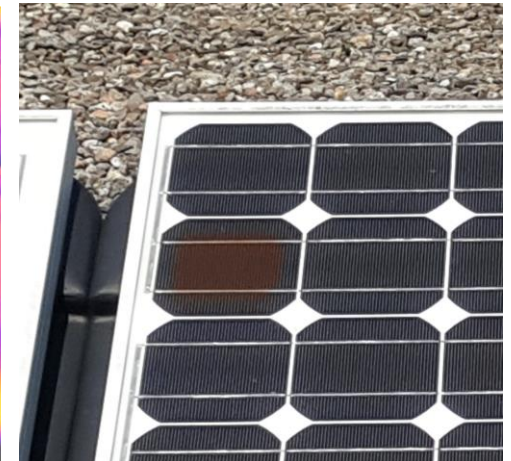
Hot spots can cause broken glasses

...and browning cells
